**MARYLAND HISTORICAL TRUST  
DETERMINATION OF ELIGIBILITY FORM**

Property Name: Buckler Property Inventory Number: PG 81A-22  
Address: 11425 Brandywine Road City: Clinton Zip Code: 20735  
County: Prince George's USGS Topographic Map: Piscataway, MD  
Owner: Jeffrey Buckler Is the property being evaluated a district? ☐ yes  
Tax Parcel Number: 86 Tax Map Number: 134 Tax Account ID Number: 0859785  
Project: Buckler Property Subdivision Agency: Army Corps of Engineers (COE)  
Site visit by MHT Staff: ☐ no ☐ yes Name: \_\_\_\_\_ Date: \_\_\_\_\_  
Is the property located within a historic district? ☐ yes ☒ no

PG: 81A-22

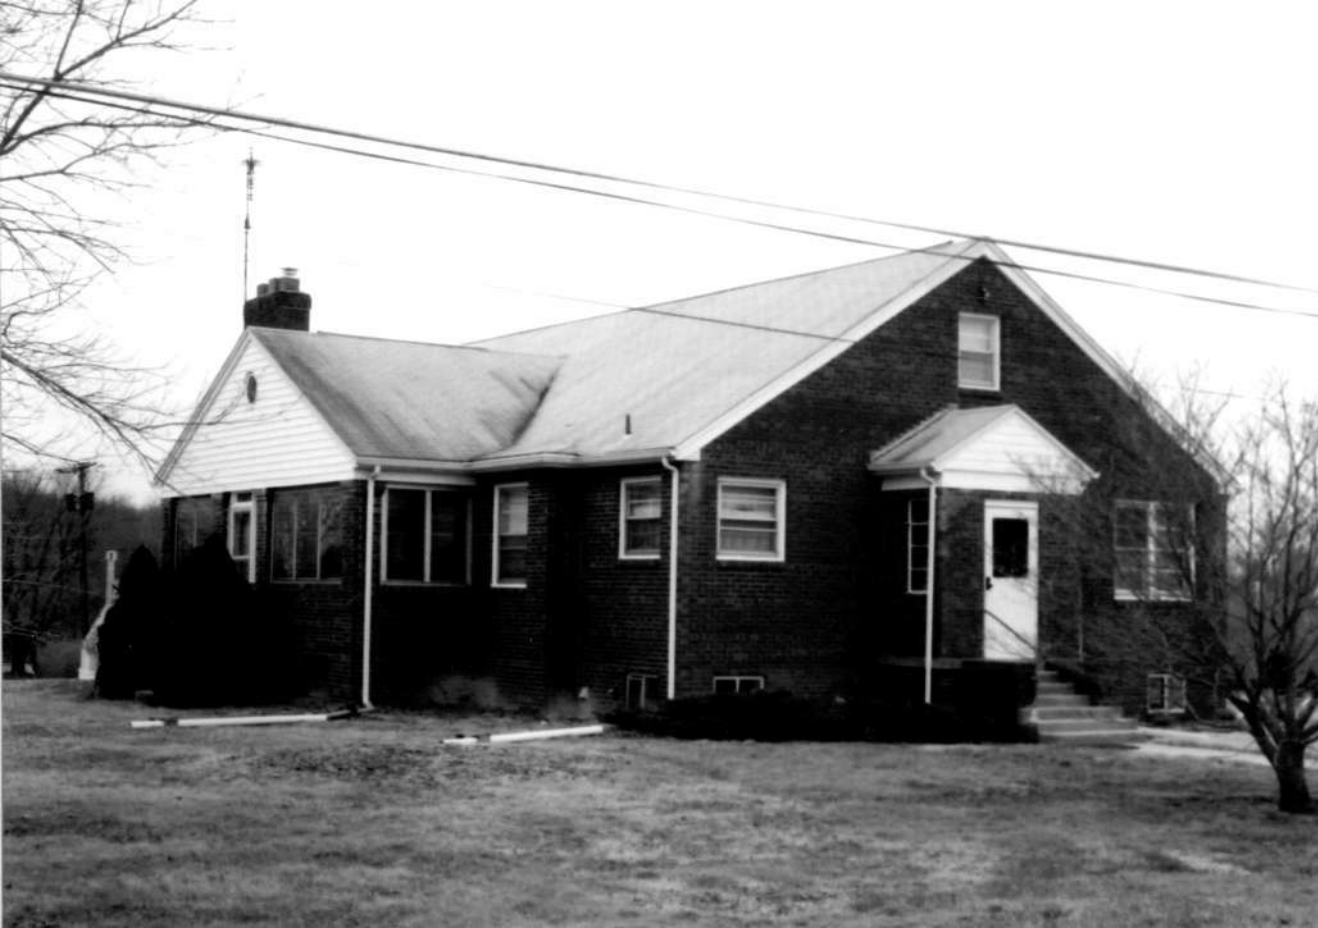
1/15

House, looking SW

This wood frame house is 1 story high, 3 bays wide, 2 bays deep and is clad with brick veneer and vinyl siding in the gable ends of the porches. The building has a moderate pitch, cross-gable roof sheathed with asphalt shingles and an exterior side wall brick masonry chimney. The windows are 2/2 wood sashes which have been paired on the east facade. The front porch has been enclosed with louvered windows.

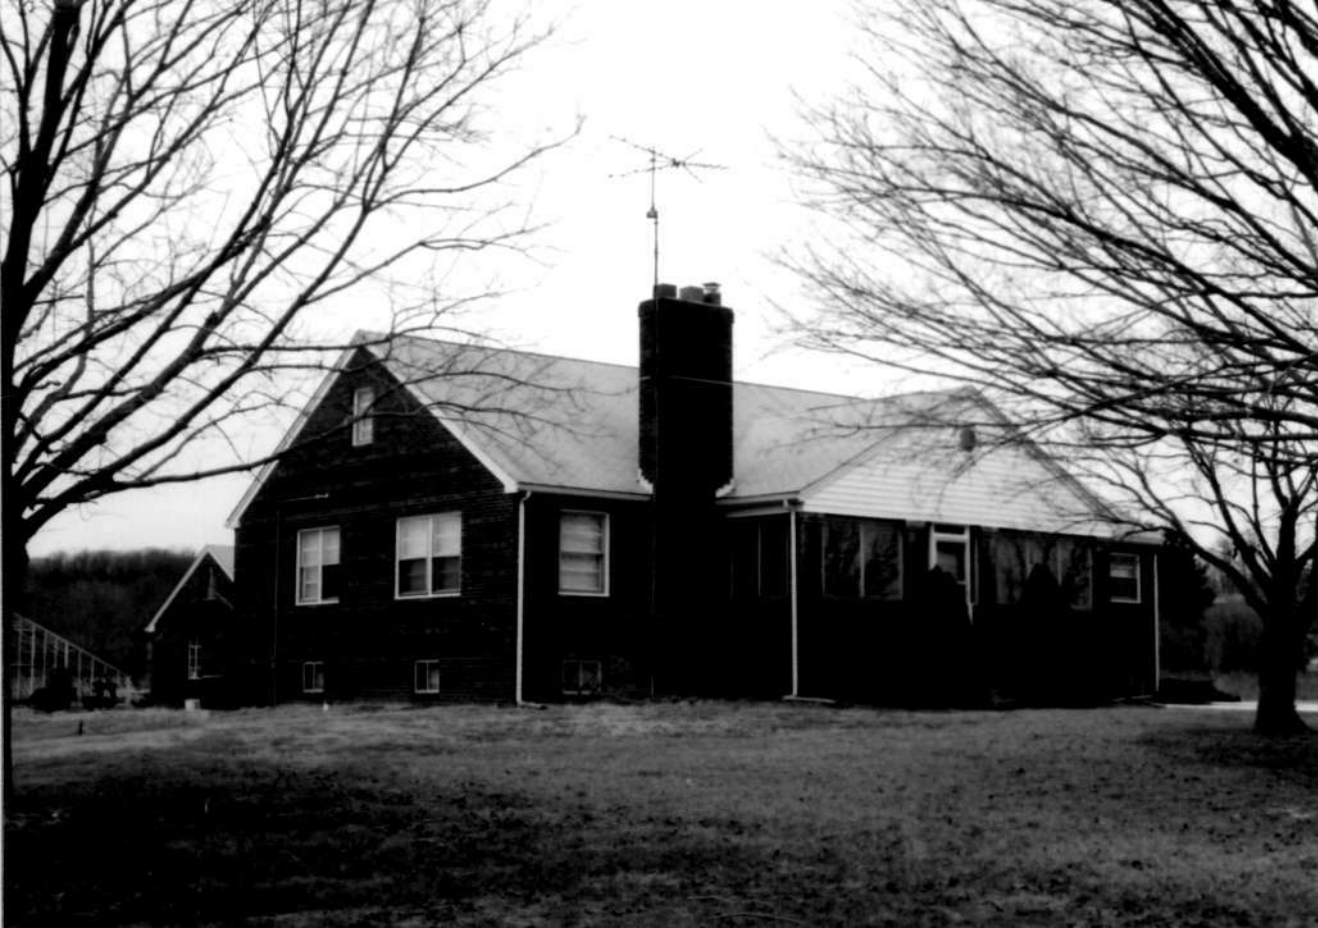
2/15

House, looking NW

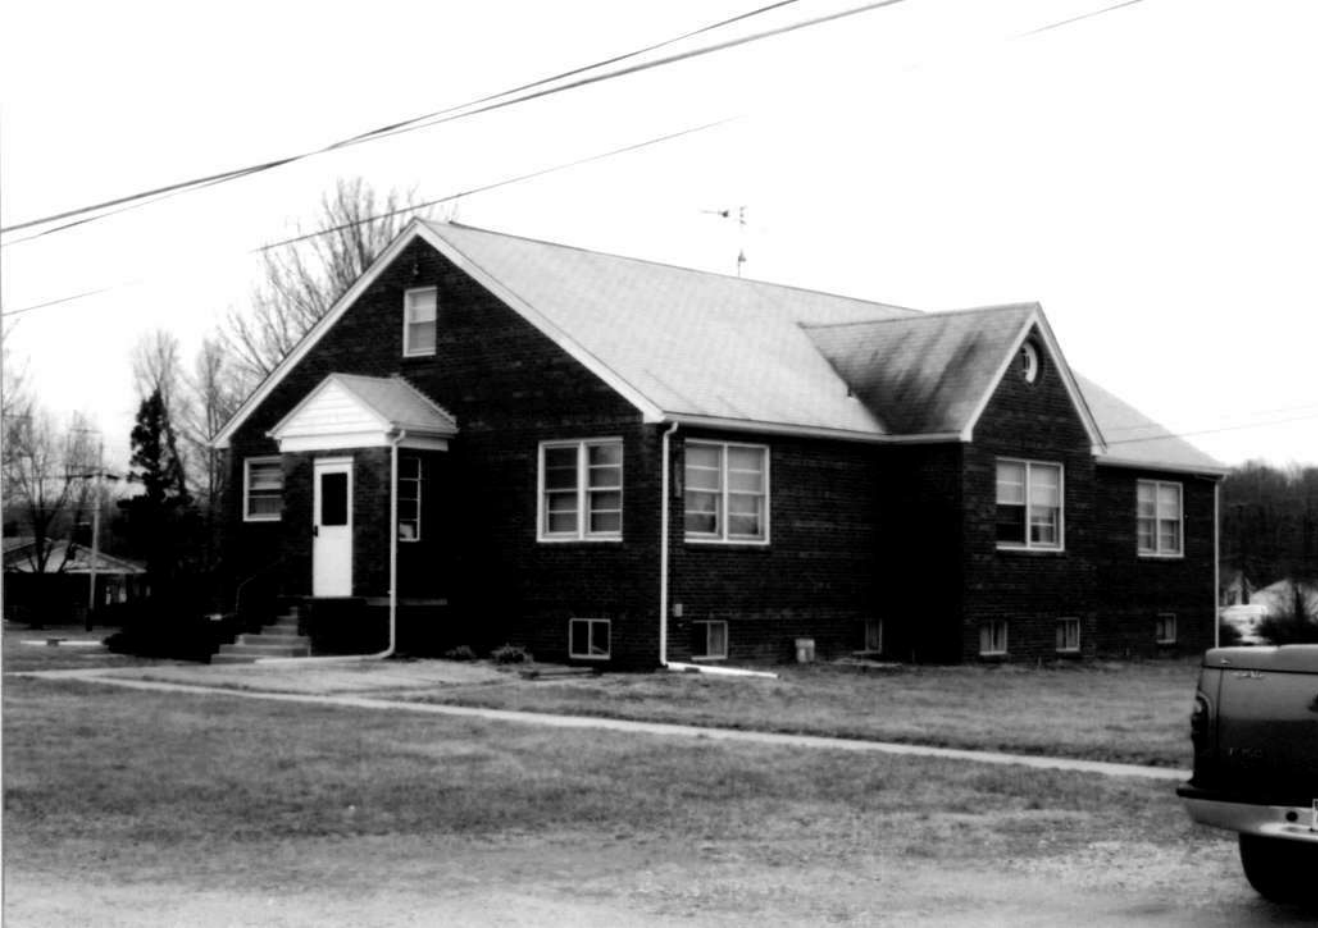
3/15

House, looking SE

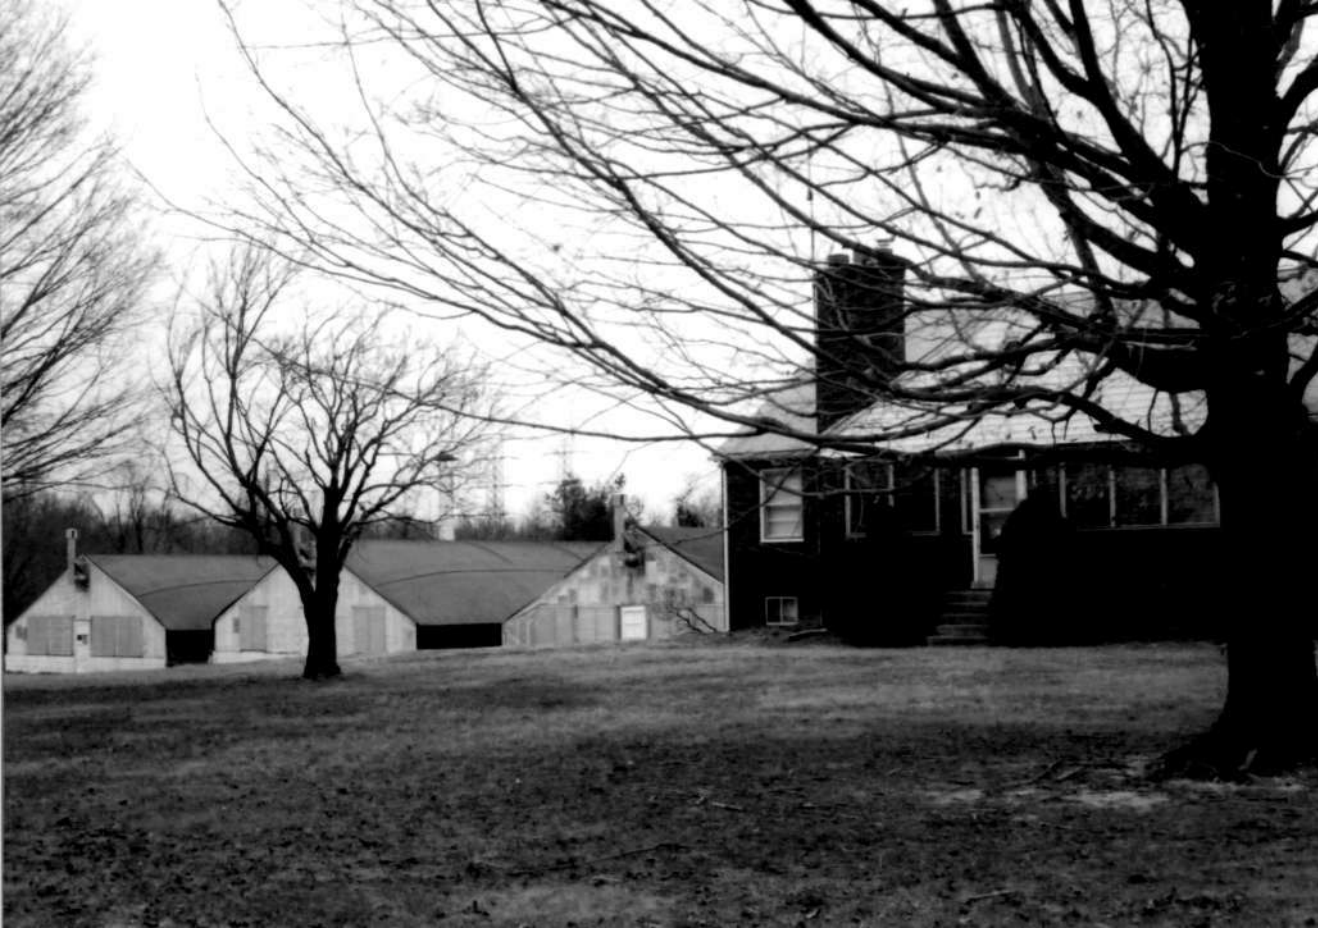
4/15

House and Greenhouses, looking SW

There are four (4) greenhouses, three (3) of which have additions, located on the property between the house and the office. These wood frame structures are 1 story high, 1 bay wide, and 1 bay deep. Each of these exhibits has a steep pitch, front-gable roof and a hollow tile masonry foundations.

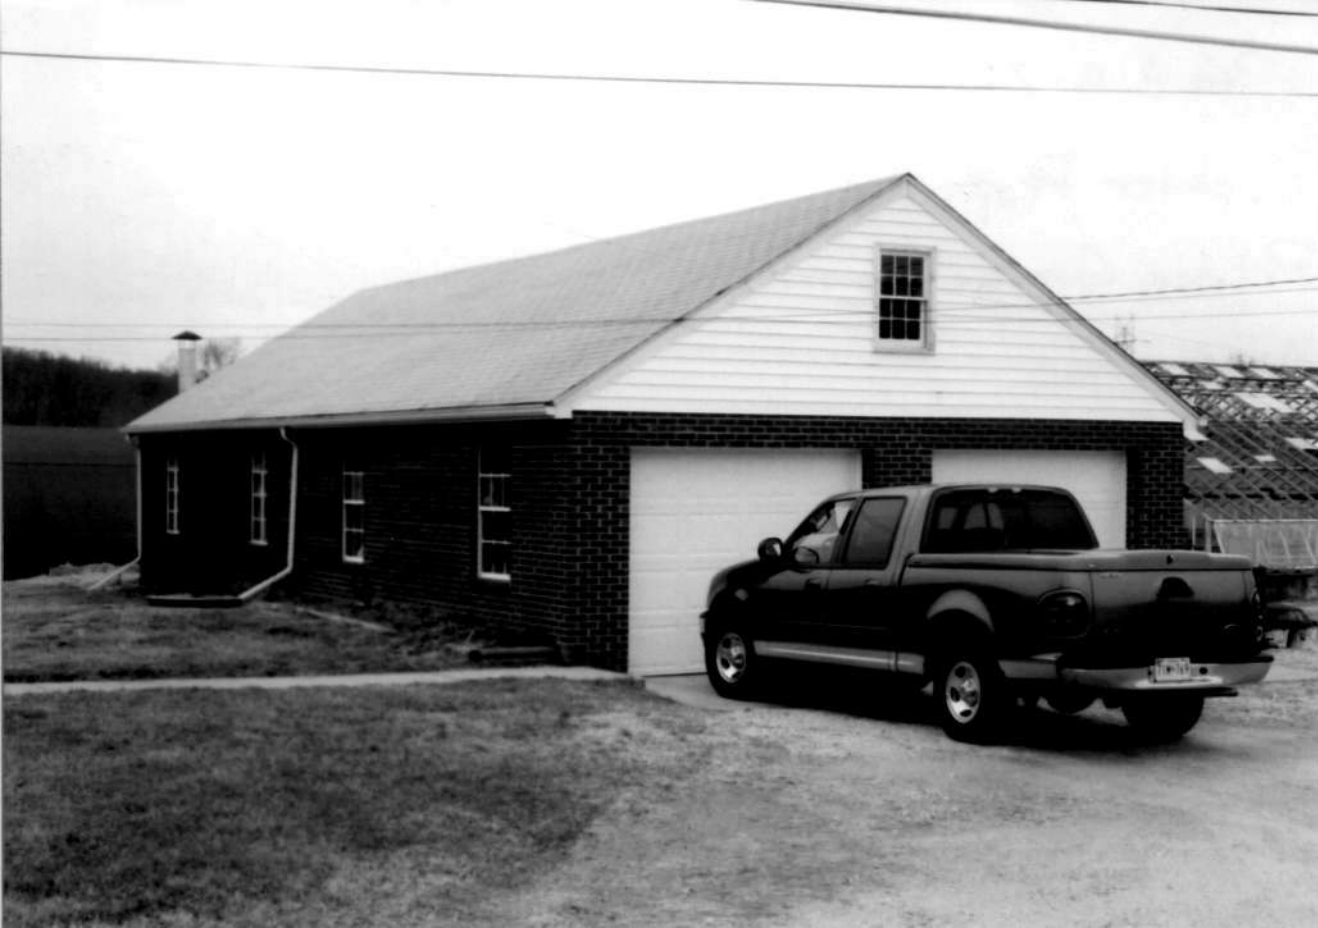
5/15

Garage 012

This garage is a wood frame structure 1 story high, 2 bays wide, and 1 bay deep located directly to the west of the main house. It is clad with brick veneer and vinyl siding in the gable ends and has a front-gable roof sheathed with asphalt shingles.

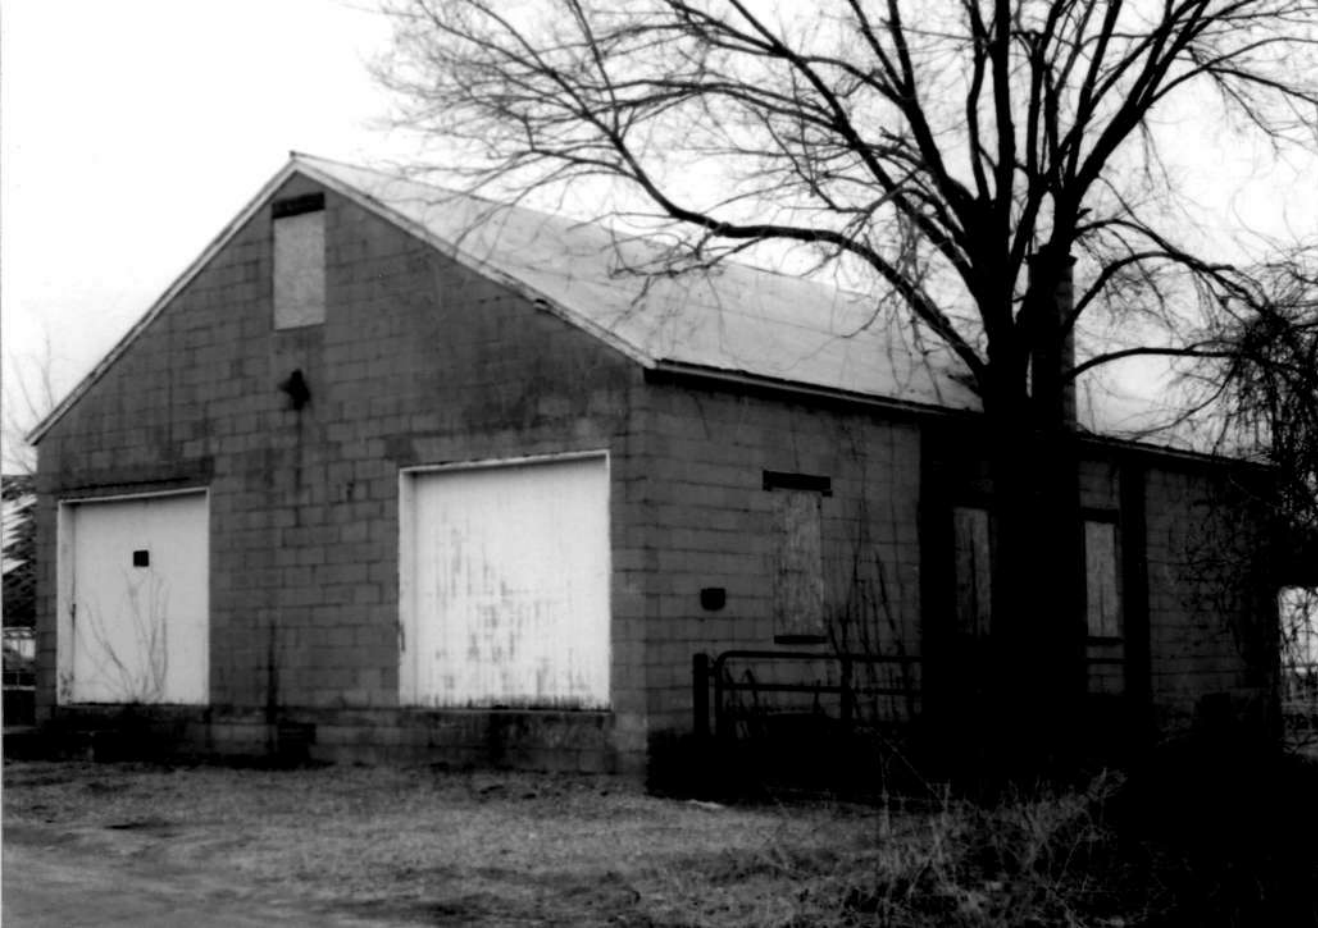
6/15

Sorting Shed

This sorting shed is a concrete masonry unit structure 1.5 stories high, 2 bays wide, and 3 bays deep located directly to the rear of the garage. The building has a front-gable roof sheathed with standing seam metal. The building was originally used for the cutting and sorting of flowers for sale to florists. The building is now used for storage.

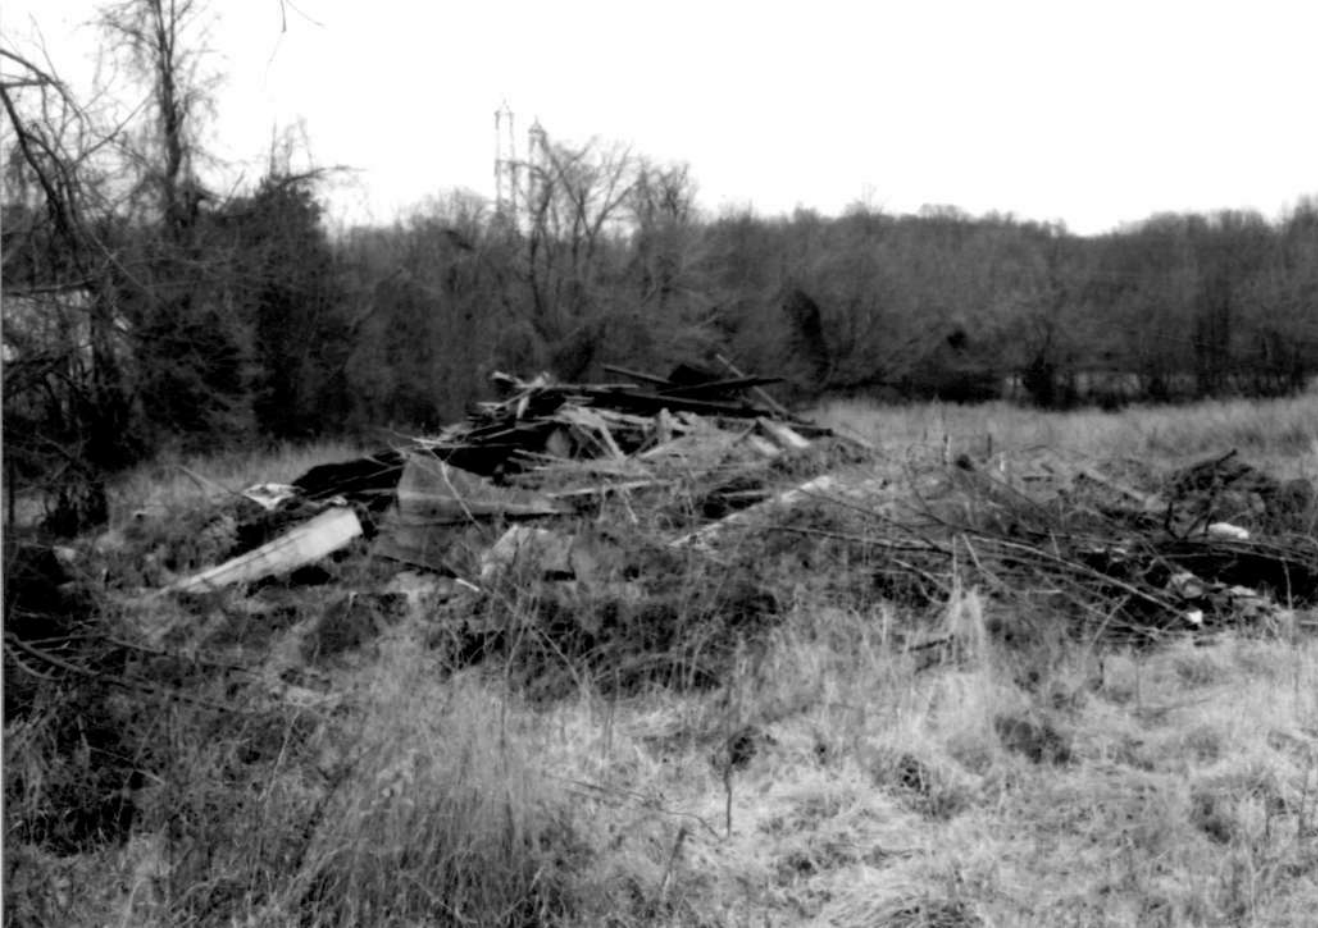
7/15

Barn Ruins

These barn ruins are located across the creek from the sorting shed and consist of a pile of building debris. The barn was demolished within the last seven years.

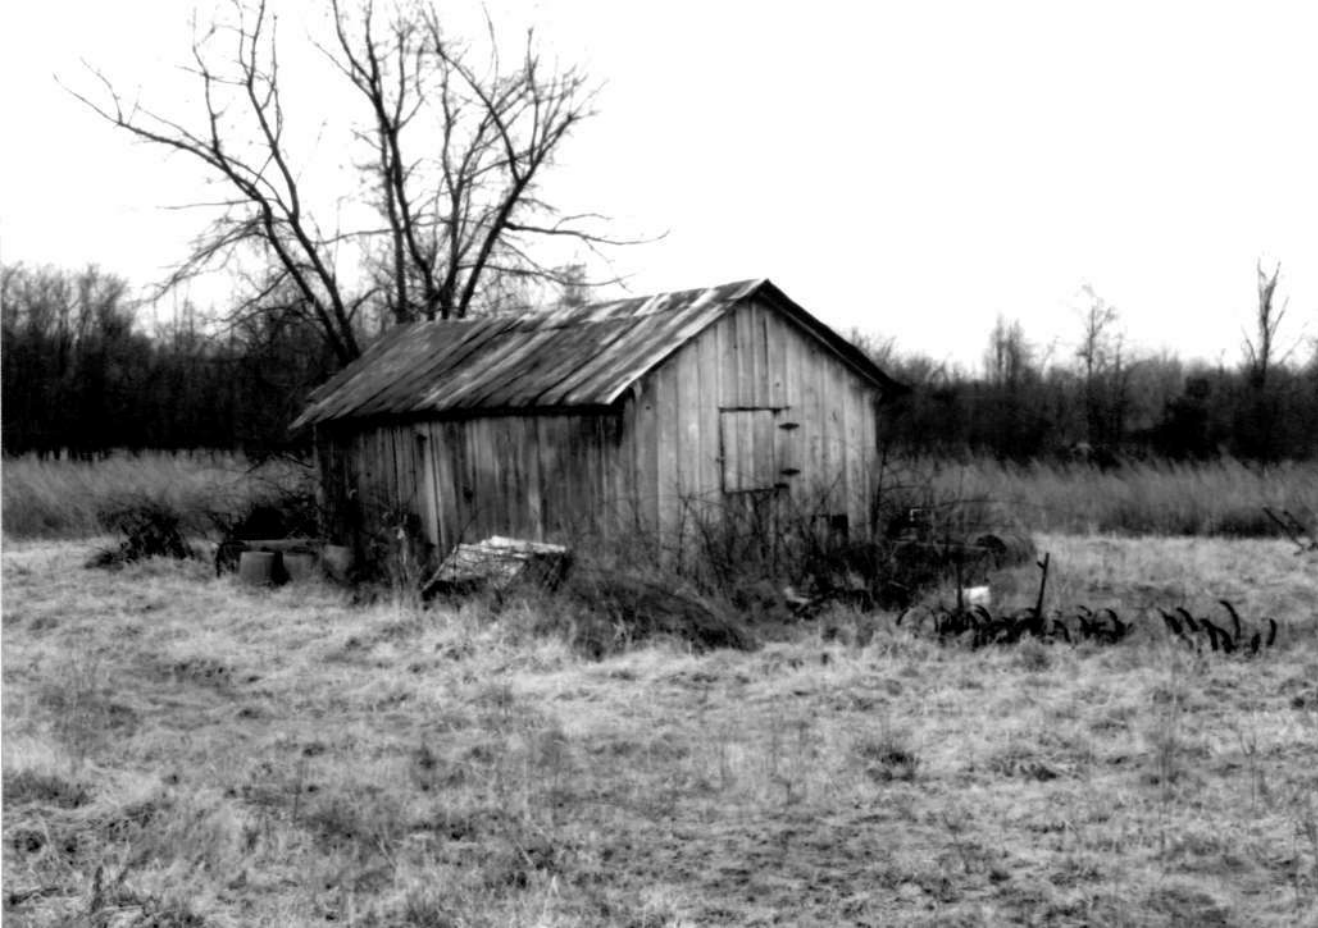
8/15

Corn Crib 010

This corn crib is a timber frame structure 1 story high, 1 bay wide, and 1 bay deep. The building is clad with vertical planks, and has a front-gable roof sheathed with asphalt paper. The building is currently vacant.

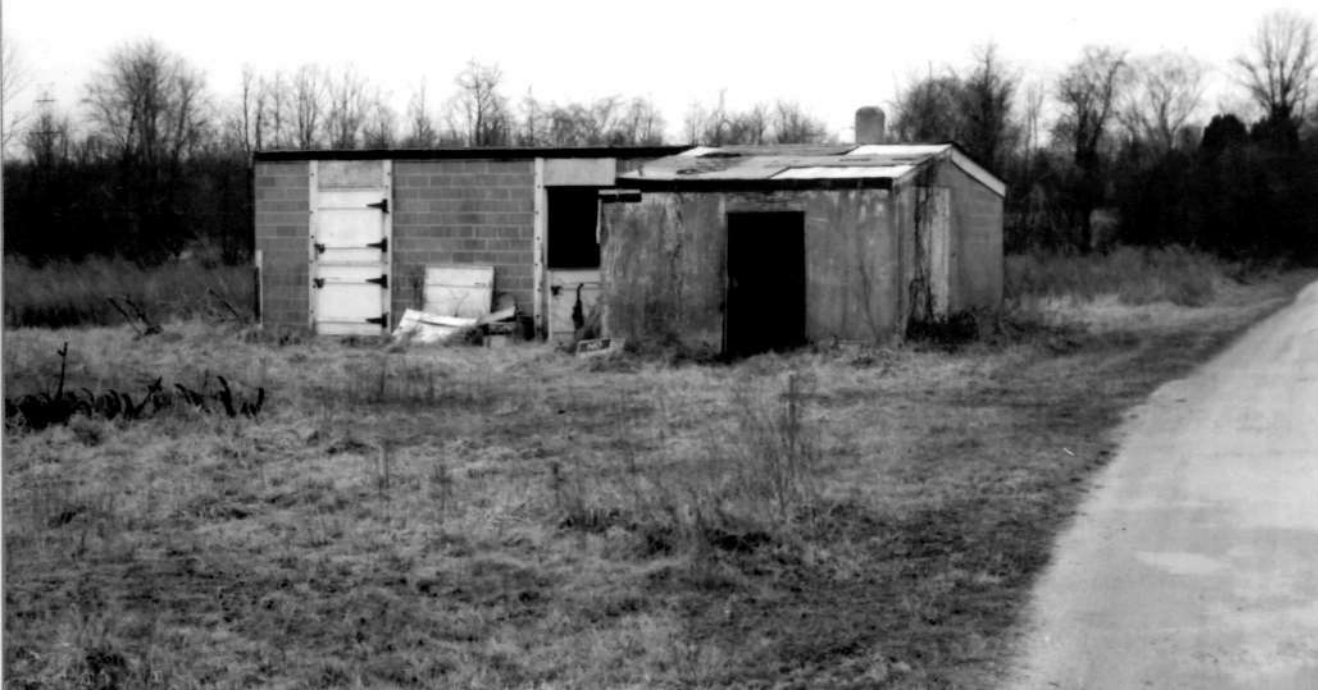
a/15

Workshop 011

This workshop is a concrete masonry unit structure 1 story high, 3 bays wide, and 1 bay deep with a wood frame addition on the east facade. The building has a shed roof sheathed with asphalt paper. The building is currently vacant.

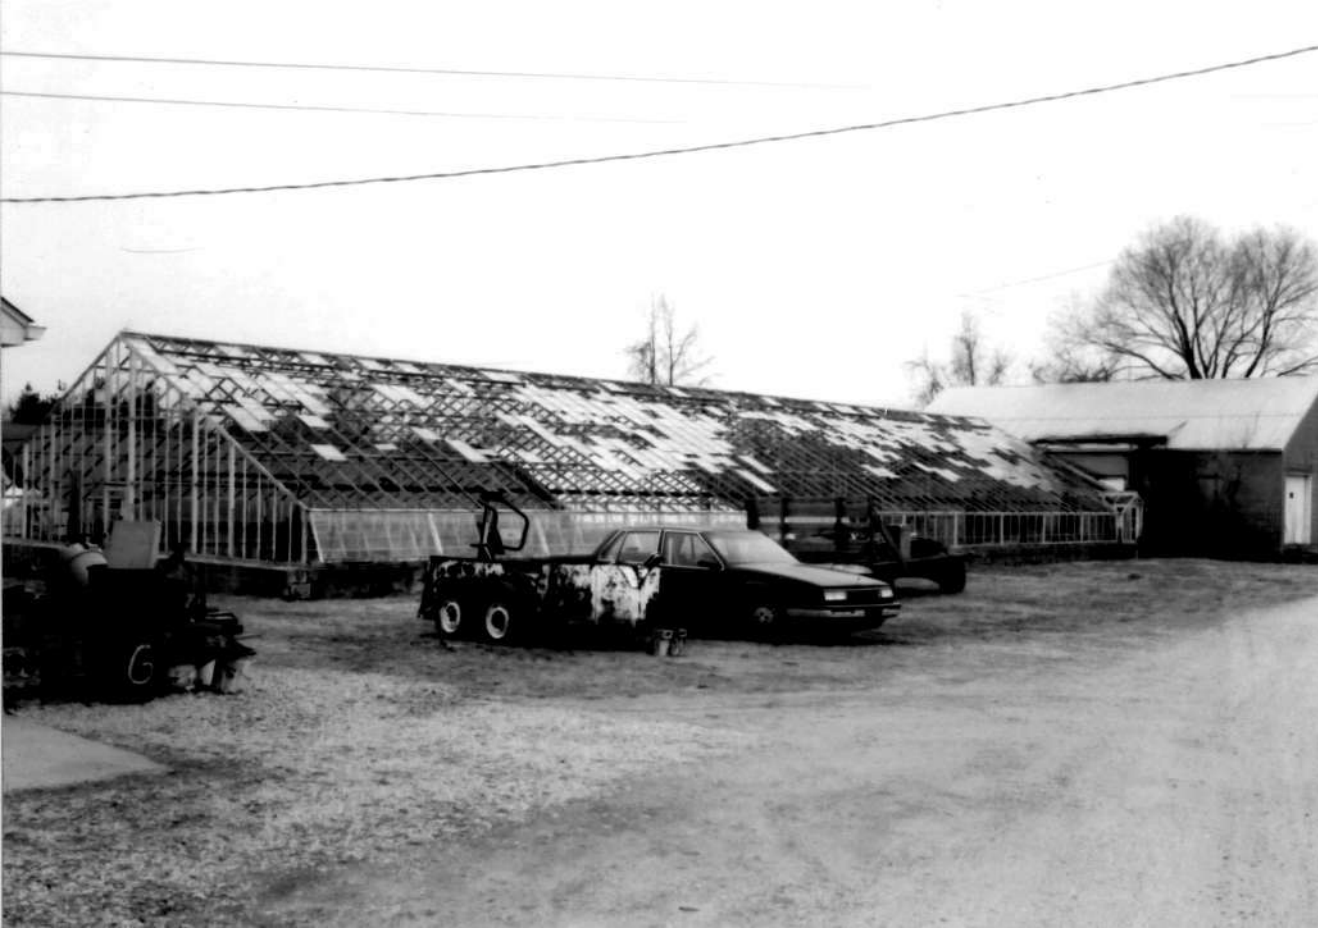
10/15

Green house, looking SW

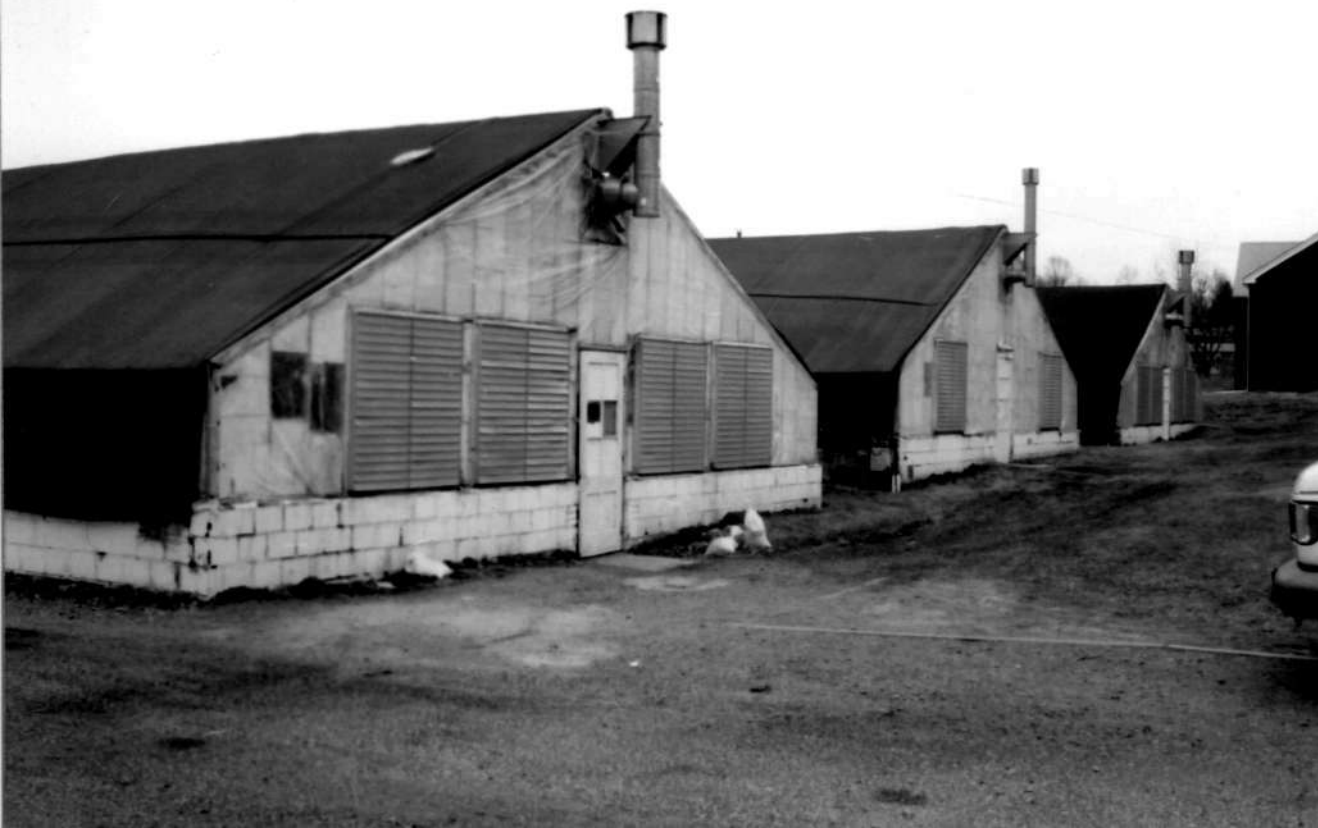
11/15

Greenhouses, looking NW

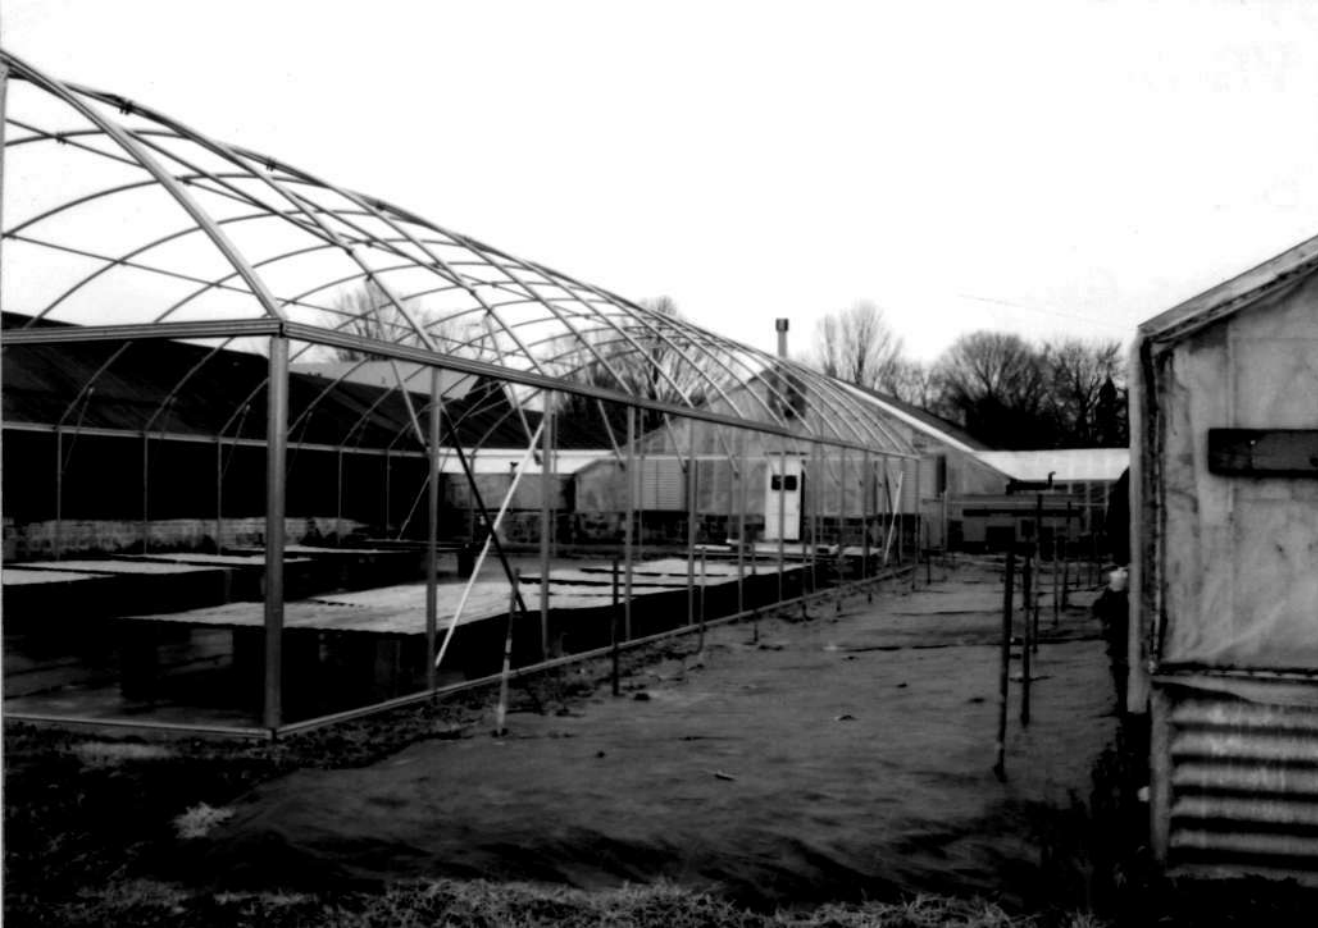
12/15

Green house Rear Additions, looking E

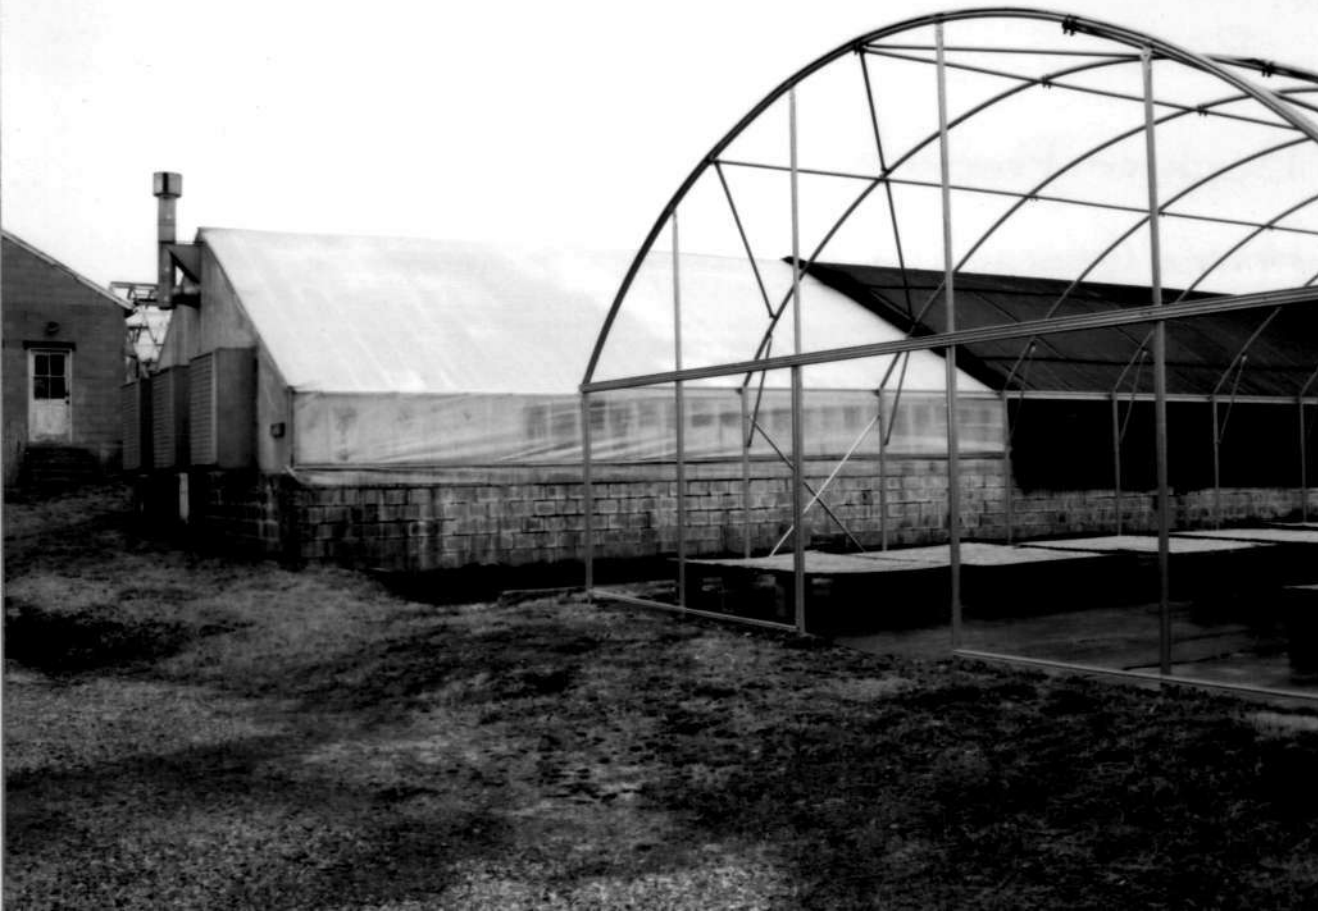
13/15

Greenhouse Rear Additions, looking NE 4042

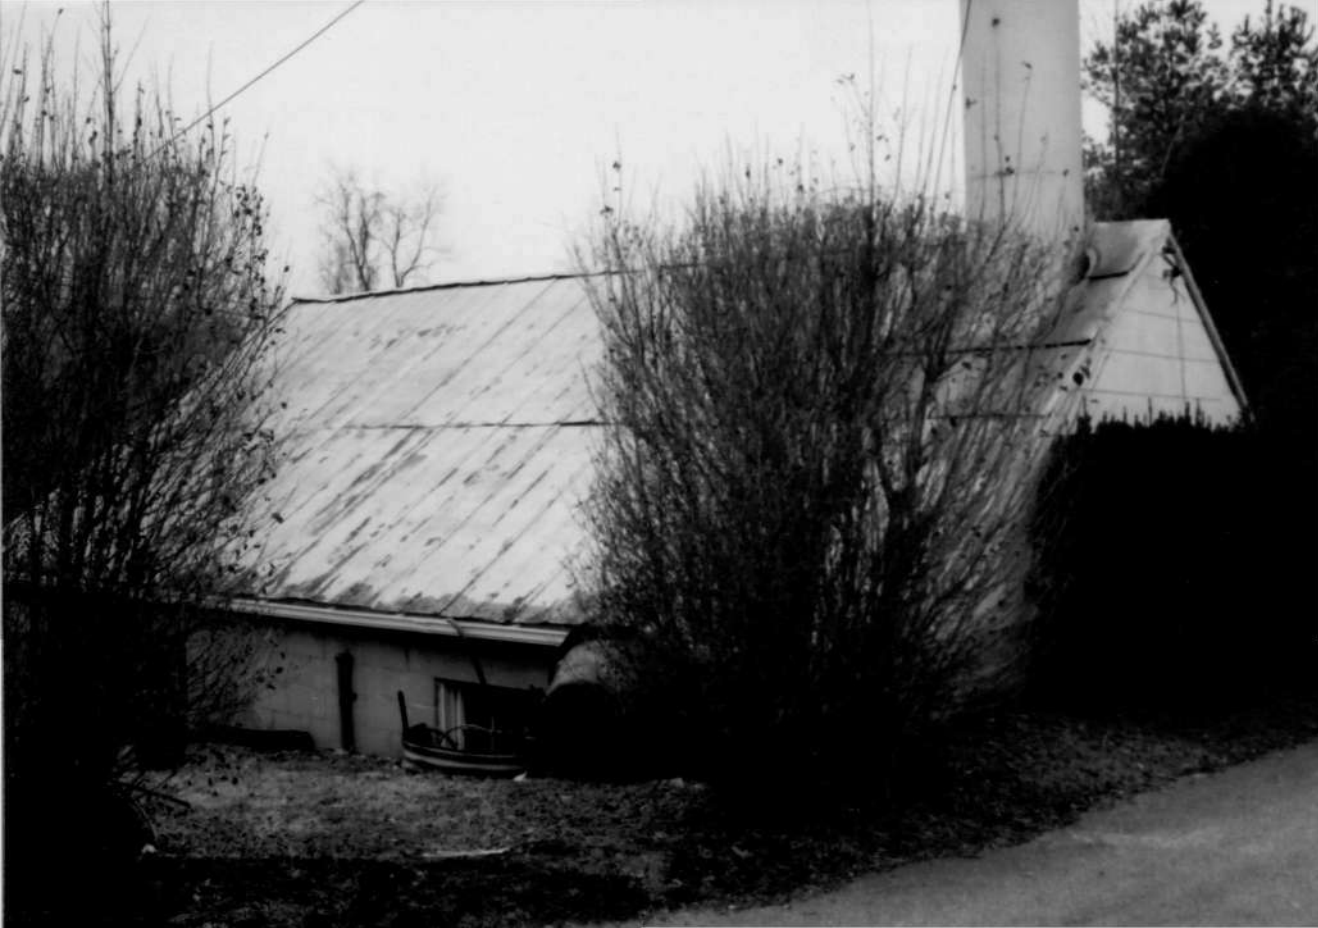
14/15

Heating Plant

This heating plant is a concrete masonry unit structure 1.5 stories high, 1 bay wide, and 2 bays deep located directly to the west of the office. The building has a front-gable roof sheathed with standing seam metal.

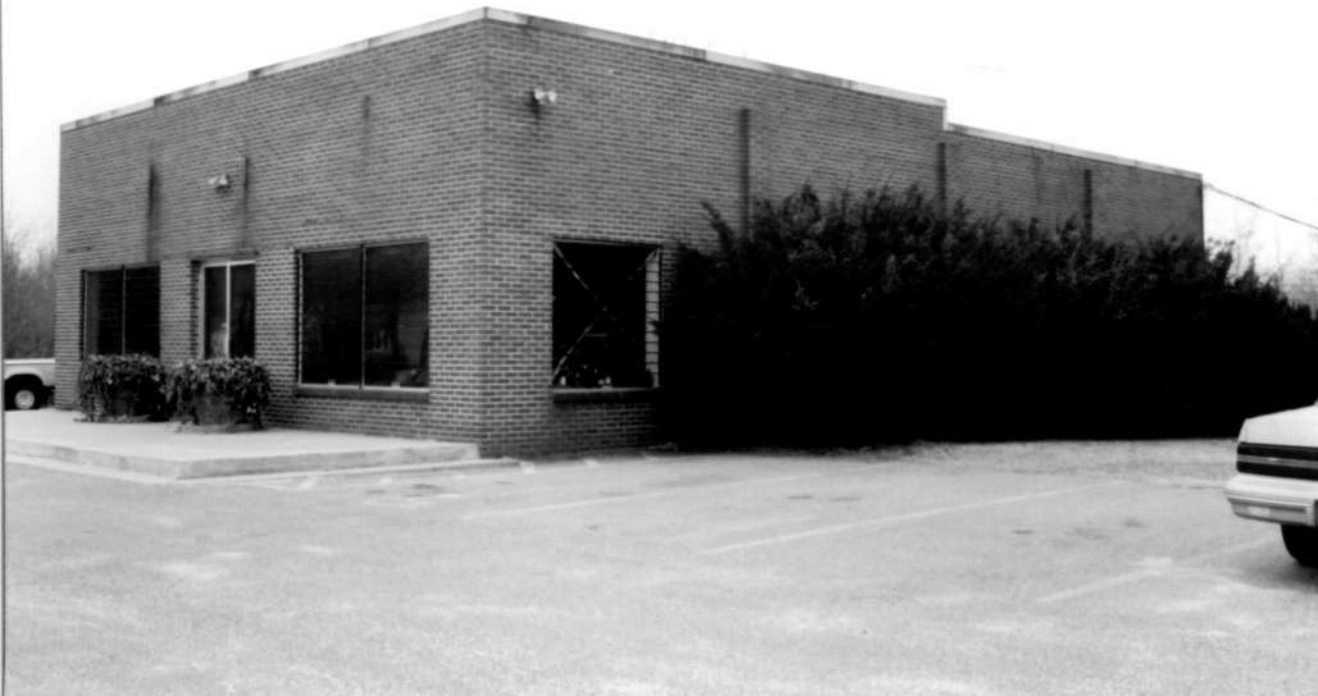
15/15

Office

This wood frame office is 1 story high, 3 bays wide, 4 bays deep and is clad with brick veneer. The building has flat roof located behind a parapet wall. The windows are large louvered panels which have been paired on the front facade.
